## The 1995 Great Hanshin Earthquake and Liquefaction Damages at Reclaimed Lands in Kobe Port

### ABSTRACT

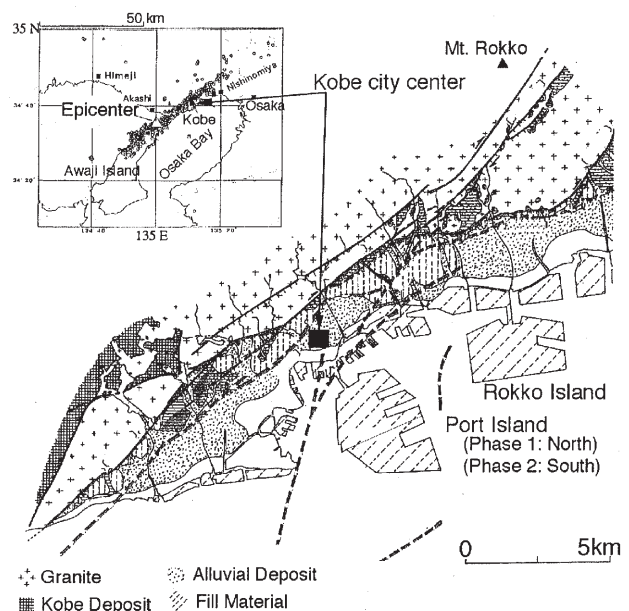
Fig. 1 Location faults in Kobe area and traces of aftershocks due to Great Hanshin Earthquake

The epicenter of the earthquake was 14 km deep and about 25 km west of Kobe City. The magnitude of the earthquake was 7.2
